Leak Detection Report

1300FINDLEAK PTY LTD

Client	
Work Order	N/A
Email	
Address	JARRAH DR ALFREDTON VIC 3350
	  -37.951608,

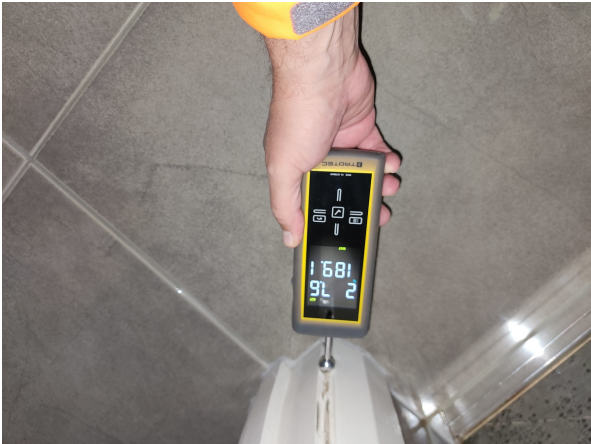
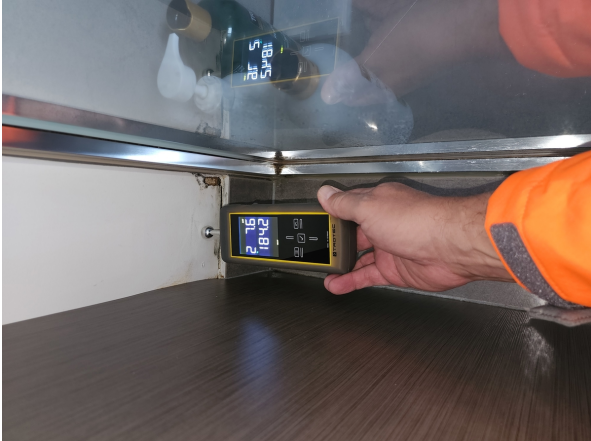
Thermal Imaging	Yes
Comments	Moisture present in separate toilet plaster wall adjacent to shower recess, plaster behind skirting tile between shower screen and vanity, toilet door jamb.
Photos

Moisture Detection	Yes
Comments	Moisture present in all affected wall footings. Note: 0-40 dry, 41-80 damp, 81 and above wet
Photos

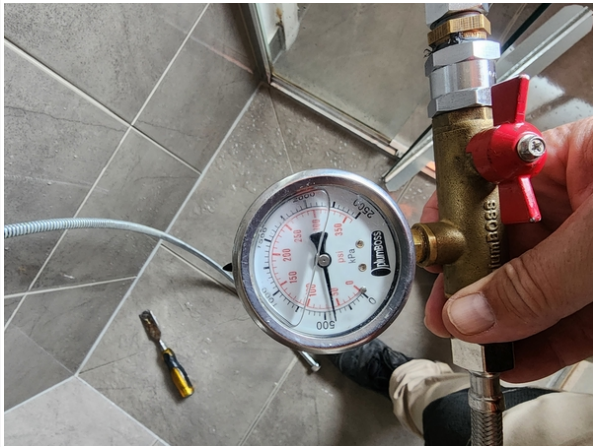
Static property hot and cold water pipework pressure test (10 minutes) held tight:	Pass
Pressure test in accordance with AS 3500.1 clause 3.3.4, The maximum inlet pressure is 500kpa:	Yes
Property water service inlet pressure (Kpa):	400
Photo

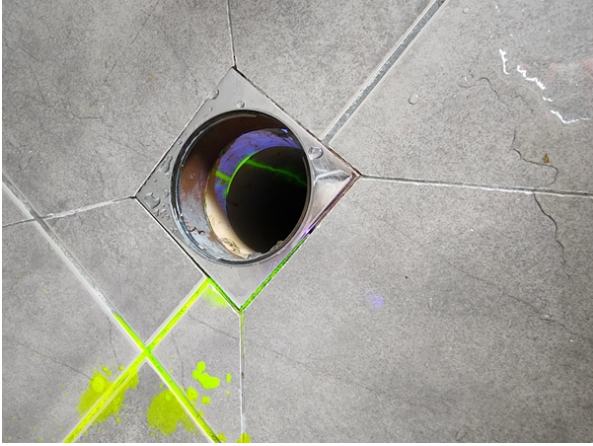
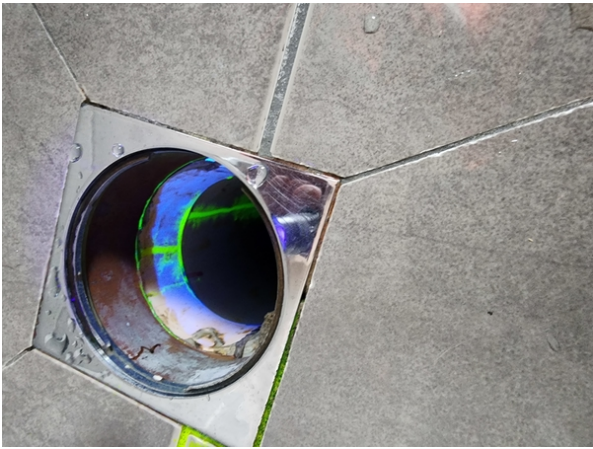
Shower/bath breach/tapware static pressure test:	Pass
Puddle flange installed - Tiled recess only	Yes
Puddle flange function	A puddle flange forms a barrier that redirects any water that may penetrate through the structure, ensuring it flows down the pipe and safely drains away.

<p>Shower waste flow & puddle flange test:</p>	<p>Pass</p>
<p>Shower base gradient as per AS 3740 Appendix 3 B3(1:100):</p>	<p>Yes</p>
<p>Tap ware penetrations sealed in accordance with AS 3740 2010 Clause 3.10.1:</p>	<p>Yes</p>

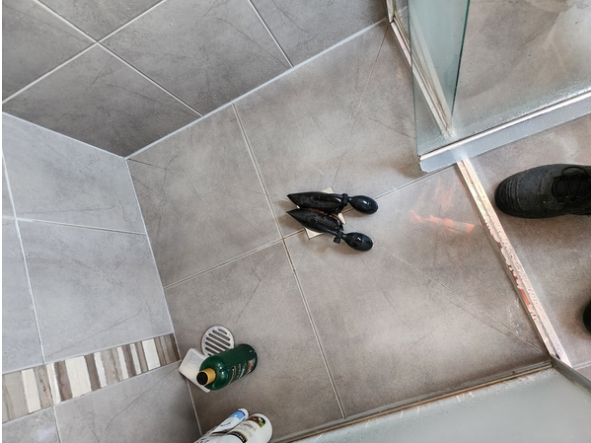
<p>Shower screen spray test as per AS 3740 2010 Clause 3.18:</p>	<p>Yes</p>
<p>Tiled shower base flood test:</p>	<p>Yes</p>
<p>Photo</p>

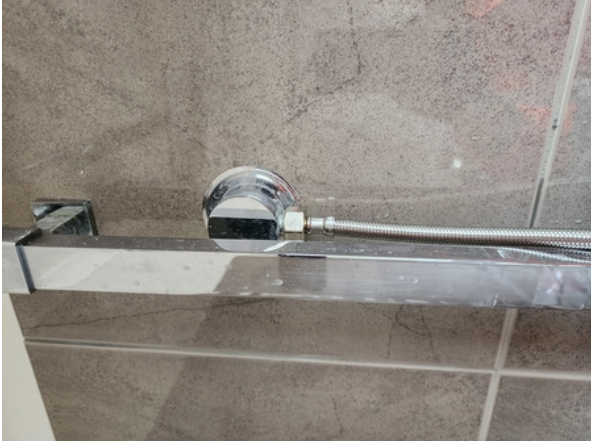
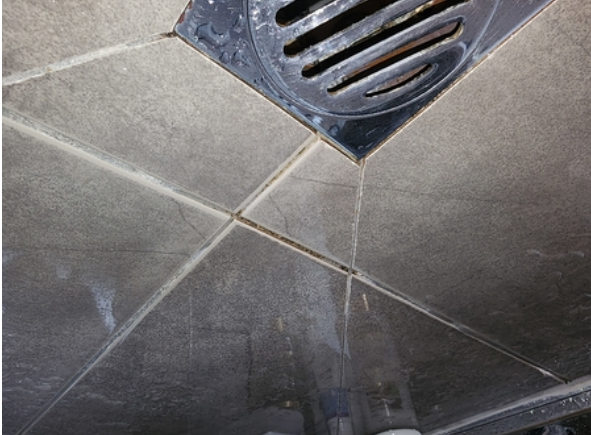
Tile grout condition:	Average
Photos

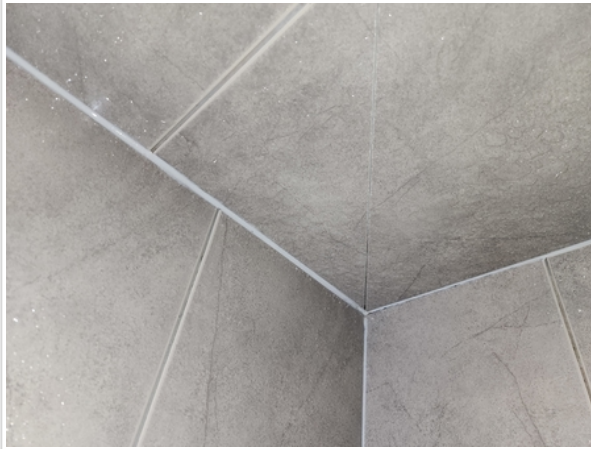
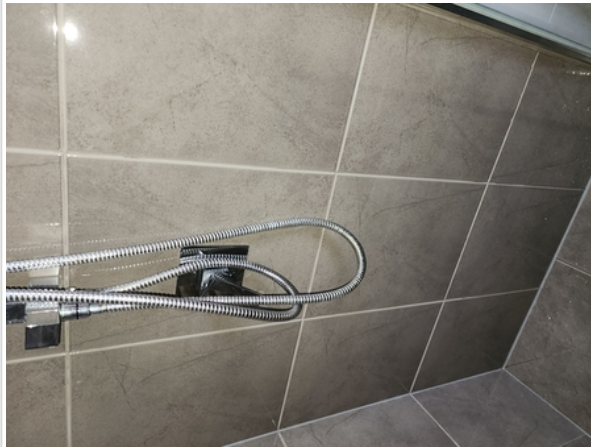
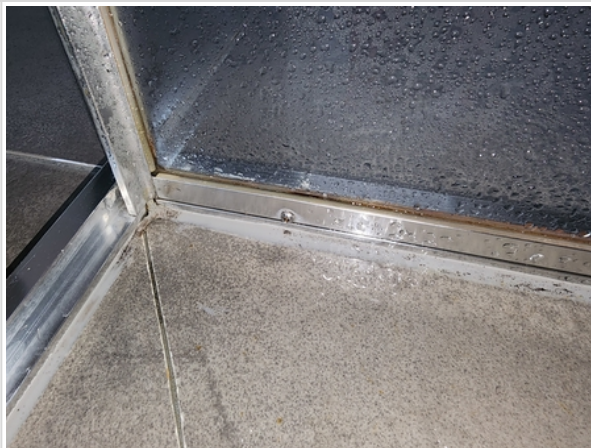
Caulking condition:

Average

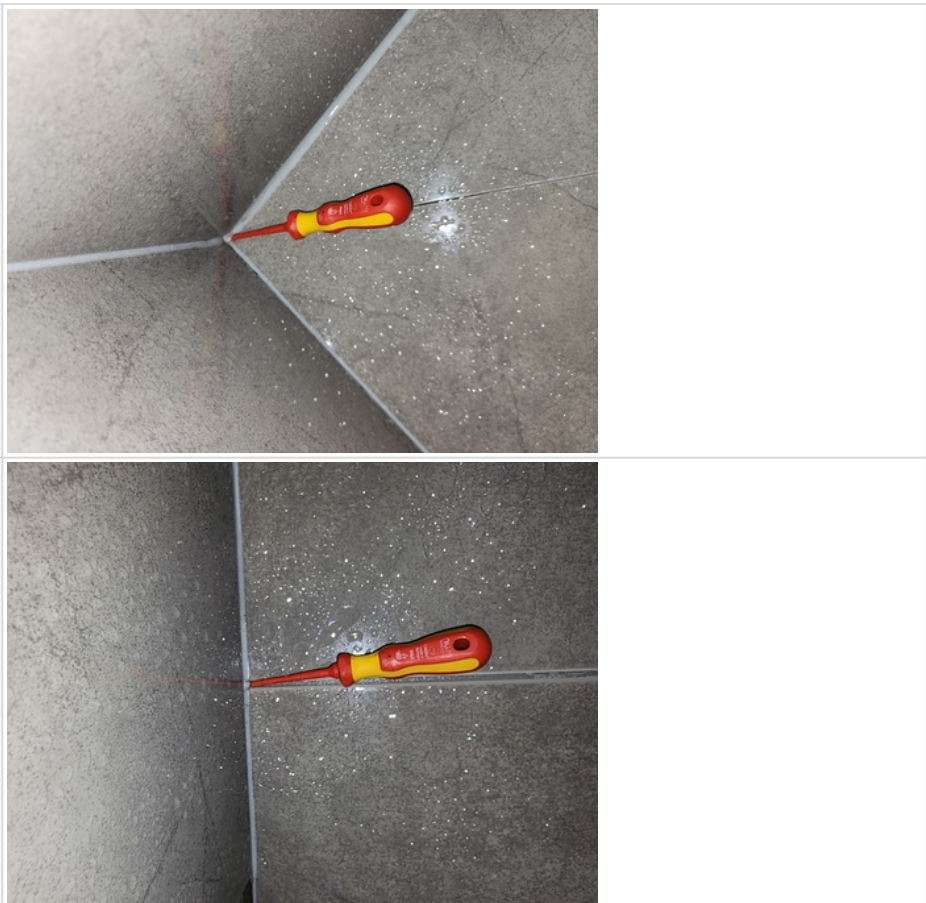
<p>Shower recess spray test:</p>	<p>Fail</p>
<p>Shower screen installed per AS 3740 2010 3.18:</p>	<p>No</p>
<p>Water stop preventing water escape from the room doorway per AS 3740 2010 Clause 3.9.1.2:</p>	<p>No</p>
<p>Waterproof membrane sound preventing adjoining room damages per AS 3740 2010 A3.5:</p>	<p>Yes</p>
<p>Test toilet waste & cistern?</p>	<p>Pass</p>
<p>Test vanity waste, hot/cold supply, taps/mixer/stop taps?</p>	<p>Pass</p>
<p>Cause of Damage</p>	<p>Installation defect, Age wear and tear, Refer to conclusion</p>

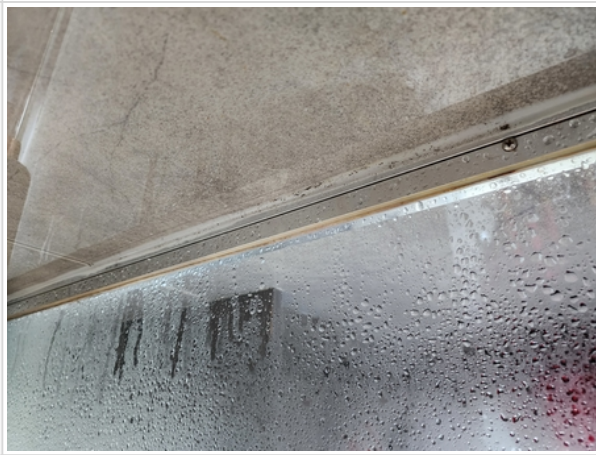
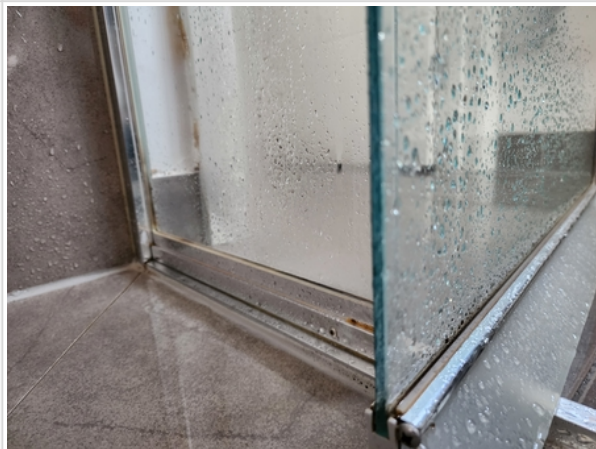
Conclusion	<p>The cause of the water damage is due to incorrect shower screen installation. Placing the semi-frameless screen on top of the grout line and sealing the inner sill with silicone prevents proper drainage, causing pooling water. Over time, this will deteriorate the grout below the shower screen sill, allowing water to ingress below the tile and skirting outside the shower.</p> <p>Furthermore, the presence of grout fractures in the tile junctions around the footing of the recess also contributes to water ingress below the tiles. The absence of floor tiles under the vanity can lead to water damage in that area as well.</p> <p>Testing the upright of the shower screen using warm water and reviewing the thermal image reveals that water is visibly traveling behind the skirting tile and exiting below the sill of the screen.</p> <p>To resolve these issues, it is recommended to address the incorrect shower screen installation by properly adjusting the screen and ensuring proper drainage. Repairing or replacing the damaged grout.</p>
