Leak Detection Report

1300FINDLEAK PTY LTD

Client	
Work Order	N/A
Email	
Address	JARRAH DR ALFREDTON VIC 3350
	  -37.951608,

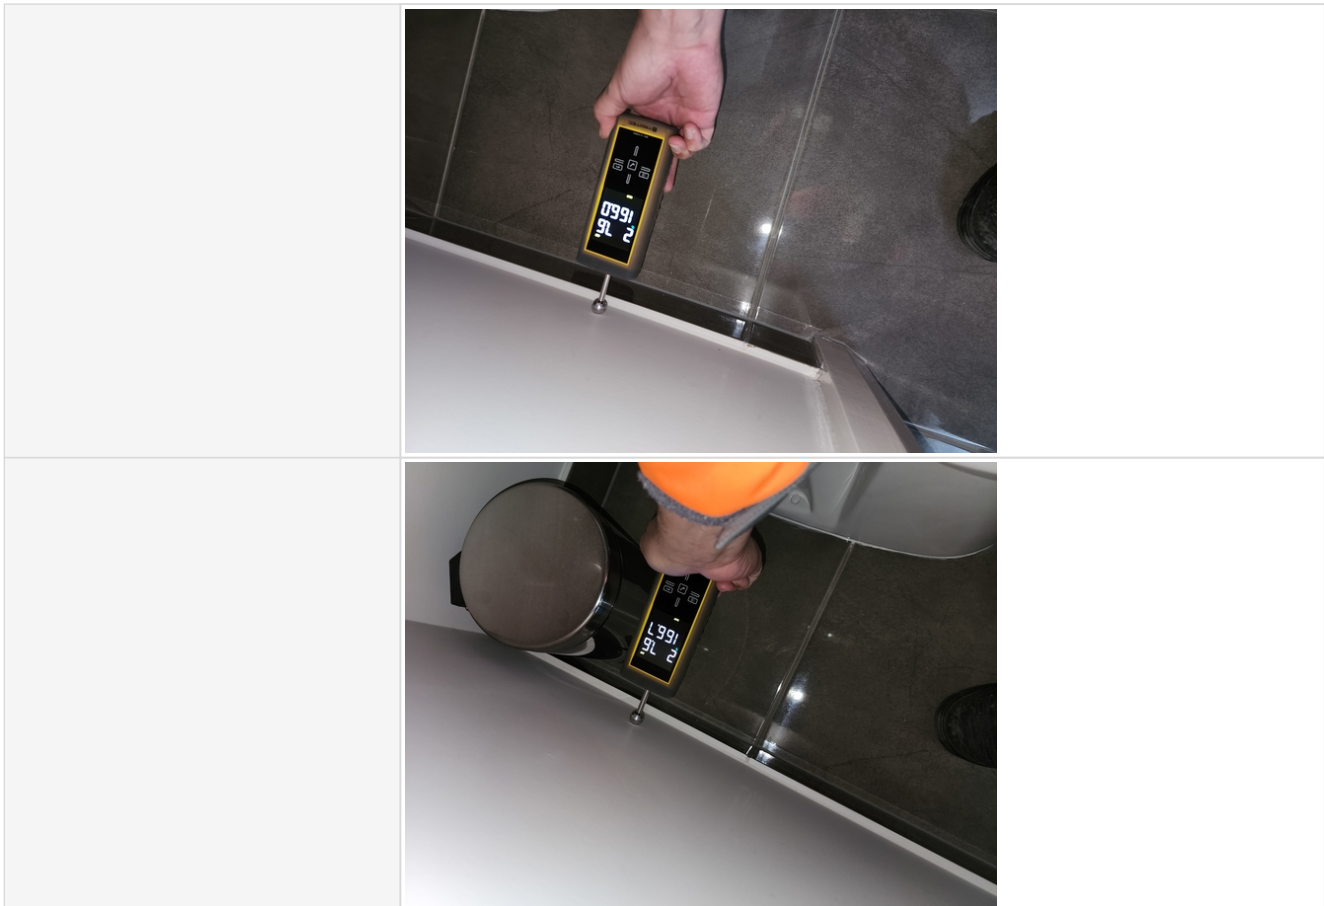
Thermal Imaging	Yes
Comments	Moisture present in separate toilet plaster wall adjacent to shower recess, plaster behind skirting tile between shower screen and vanity, toilet door jamb.
Photos

Moisture Detection	Yes
Comments	Moisture present in all affected wall footings. Note: 0-40 dry, 41-80 damp, 81 and above wet
Photos

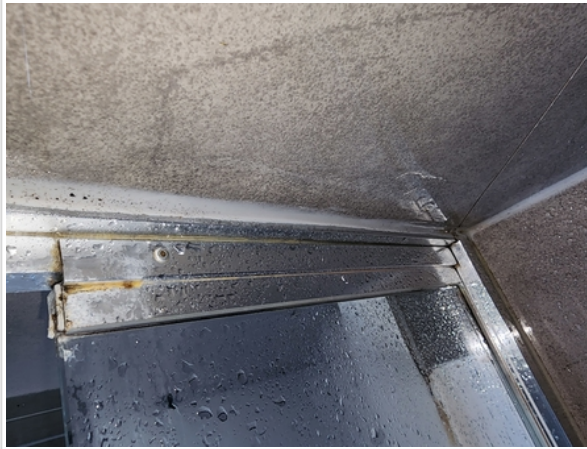
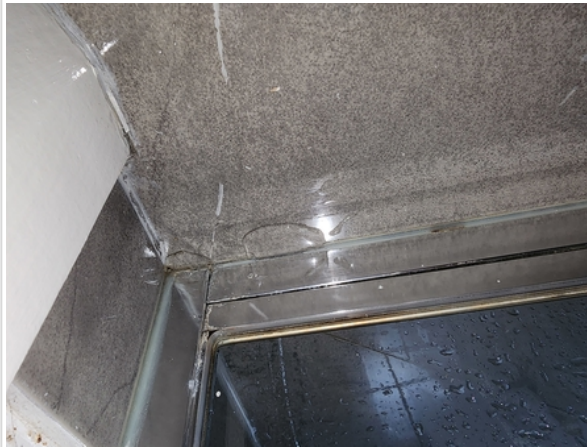
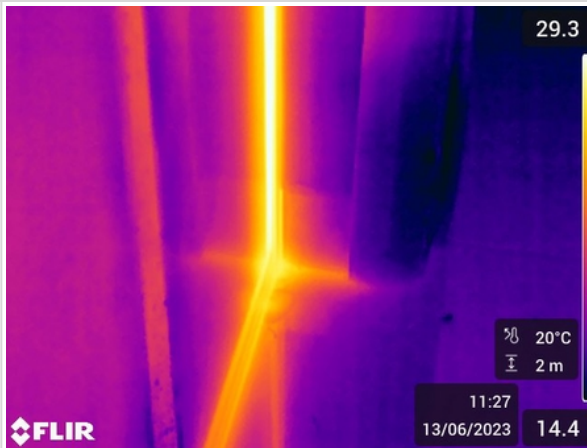
<p>Shower recess spray test:</p>	<p>Fail</p>
<p>Shower screen installed per AS 3740 2010 3.18:</p>	<p>No</p>
<p>Water stop preventing water escape from the room doorway per AS 3740 2010 Clause 3.9.1.2:</p>	<p>No</p>
<p>Waterproof membrane sound preventing adjoining room damages per AS 3740 2010 A3.5:</p>	<p>Yes</p>
<p>Test toilet waste & cistern?</p>	<p>Pass</p>
<p>Test vanity waste, hot/cold supply, taps/mixer/stop taps?</p>	<p>Pass</p>
<p>Cause of Damage</p>	<p>Installation defect, Age wear and tear, Refer to conclusion</p>

Conclusion	<p>The cause of the water damage is due to incorrect shower screen installation. Placing the semi-frameless screen on top of the grout line and sealing the inner sill with silicone prevents proper drainage, causing pooling water. Over time, this will deteriorate the grout below the shower screen sill, allowing water to ingress below the tile and skirting outside the shower.</p> <p>Furthermore, the presence of grout fractures in the tile junctions around the footing of the recess also contributes to water ingress below the tiles. The absence of floor tiles under the vanity can lead to water damage in that area as well.</p> <p>Testing the upright of the shower screen using warm water and reviewing the thermal image reveals that water is visibly traveling behind the skirting tile and exiting below the sill of the screen.</p> <p>To resolve these issues, it is recommended to address the incorrect shower screen installation by properly adjusting the screen and ensuring proper drainage. Repairing or replacing the damaged grout.</p>
